# **BATTLESHIP TEXAS (BB-35)**

## **VESSEL INSPECTION AND ASSESSMENT**

Vessel Survey Report No. 2417

Vessel surveyed at:	La Porte, Texas
Dates of survey:	November - December 2010 January 2011
Vessel surveyed:	Battleship TEXAS (BB-35)
Survey commissioned by:	Texas Parks & Wildlife Battleship TEXAS State Historic Site 3523 Independence Parkway South La Porte, Texas 77571
Purpose of survey:	Vessel Condition Survey

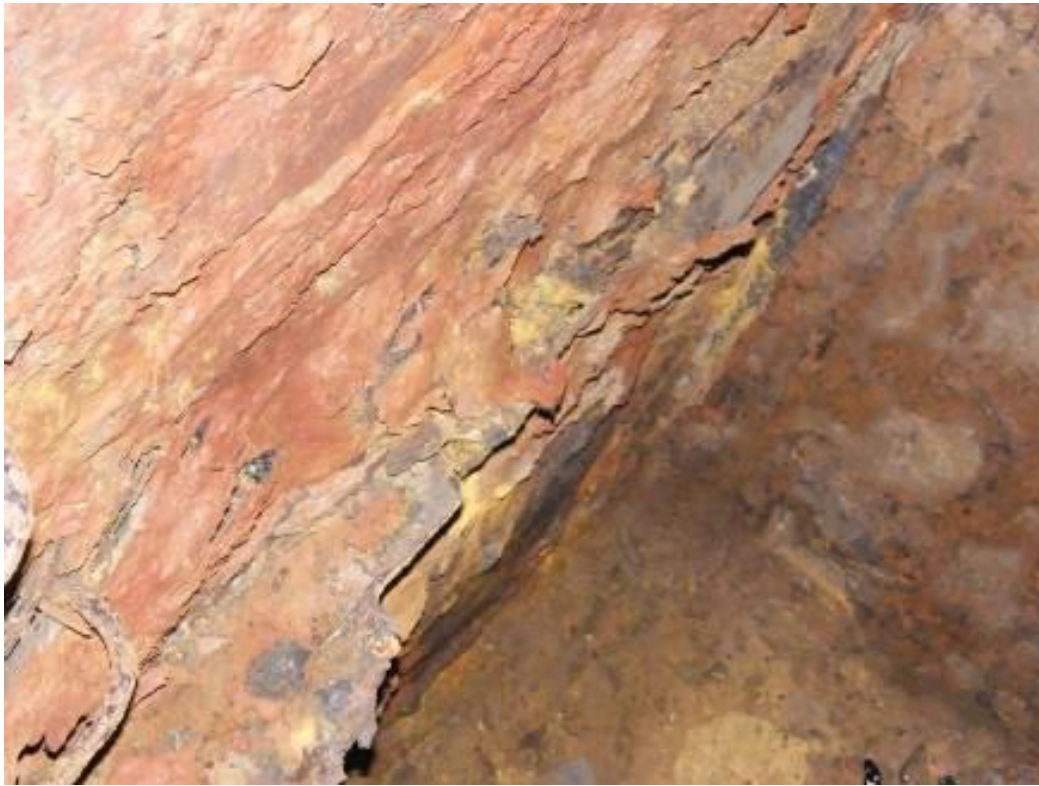
**Figure 402 Wastage at Forward Bulkhead in Bilges at Hull Bottom Without Any Good Metal  
(Trimming Tank Void D-13V)**
